Architectural Survey of Ohio Army National Guard Properties: Volume I

December 2015

Under Project 405180, "OHARNG Architectural Survey"

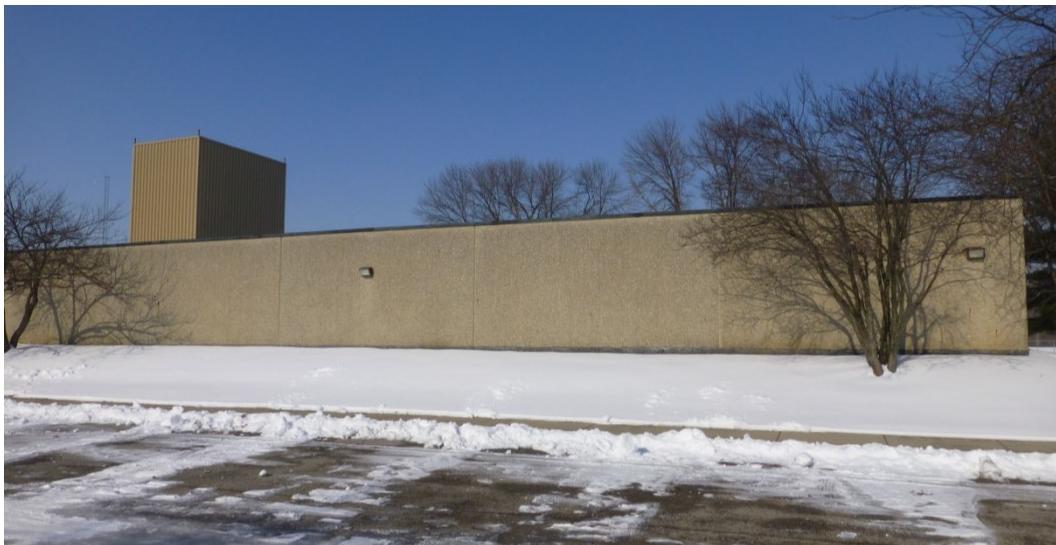
Figure 99. Southeast elevation of Building 943 (ERDC-CERL, 2014).

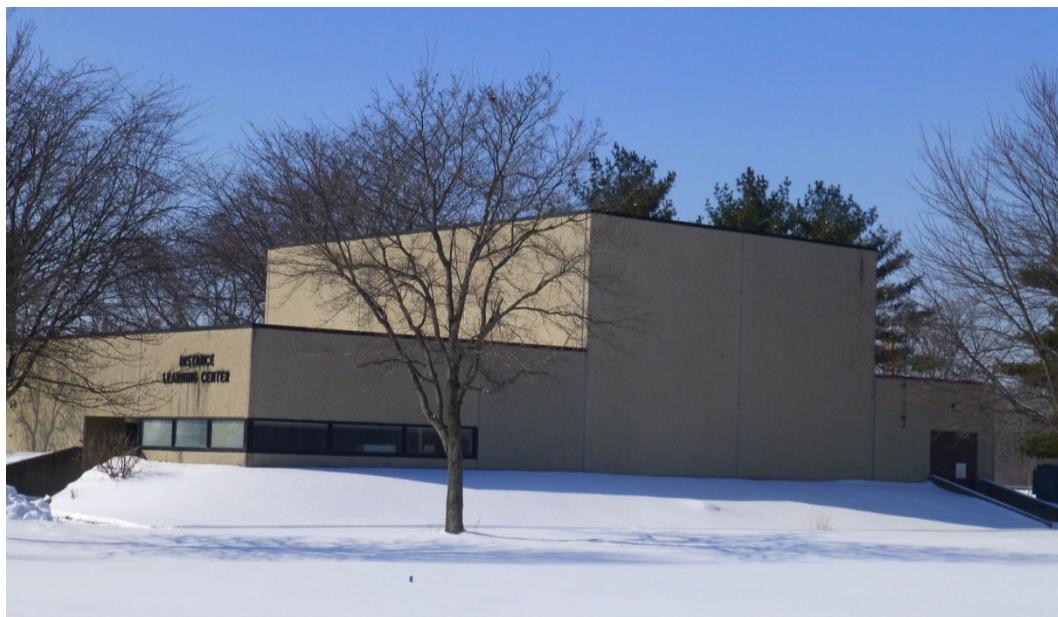
Figure 100. East oblique of Building 944 (ERDC-CERL, 2014).

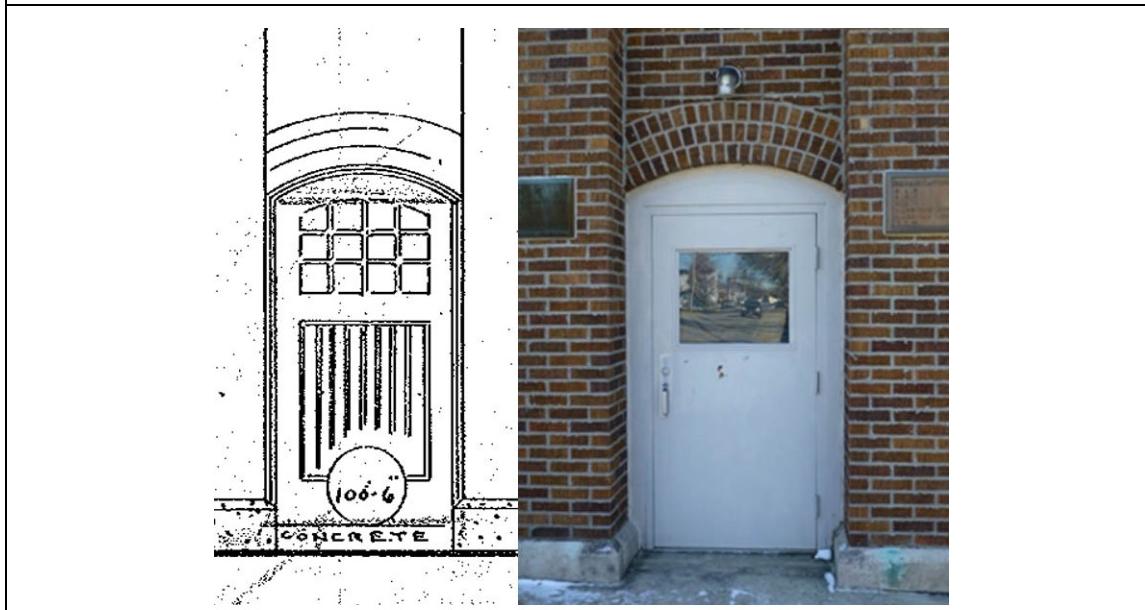
Single-entry door on the northwest (front) elevation: original design and materials with arched wood door with multi-light top on the left (1920 drawing), compared to the current condition of the replacement metal door and modified door arched door opening on the right (ERDC-CERL, 2013).

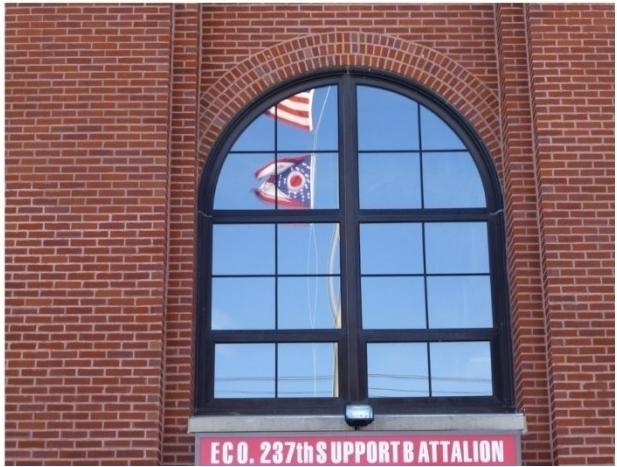
Arched window on northwest (front) elevation: original design and materials (metal frame with wire-glass awning window) on the left (drawing), compared to the current condition of the elevation with replacement anodized-bronze aluminum windows on the right
(ERDC-CERL, 2013).

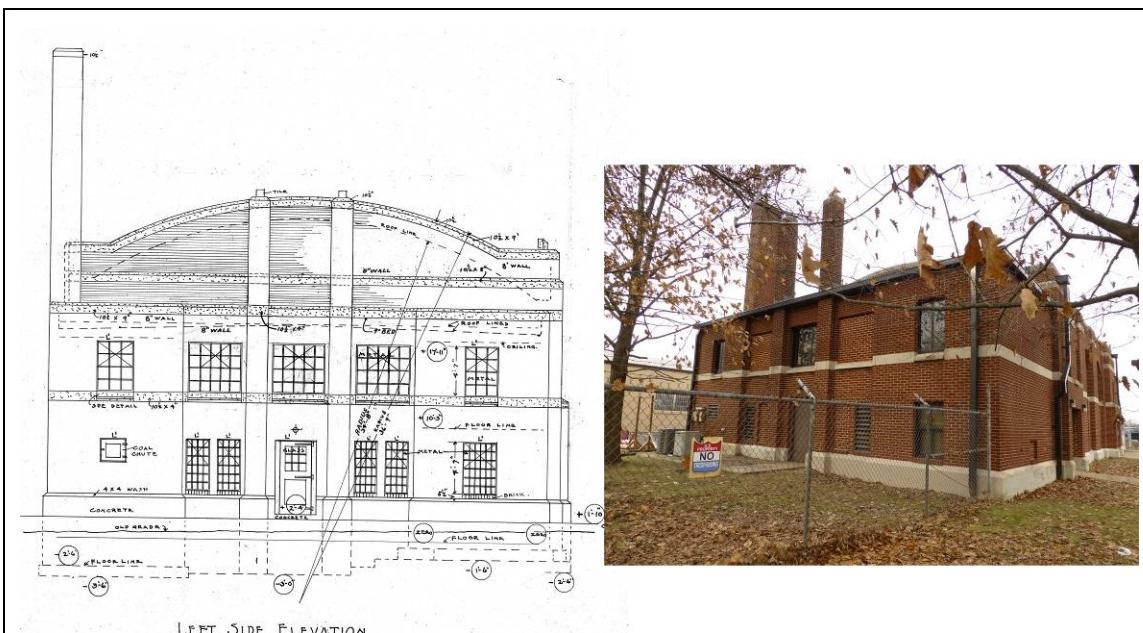
South elevation: original (1937 drawing) on the left and current photograph on the right (ERDC-CERL, 2013). Note that some of the original windows have been removed and filled with brick.

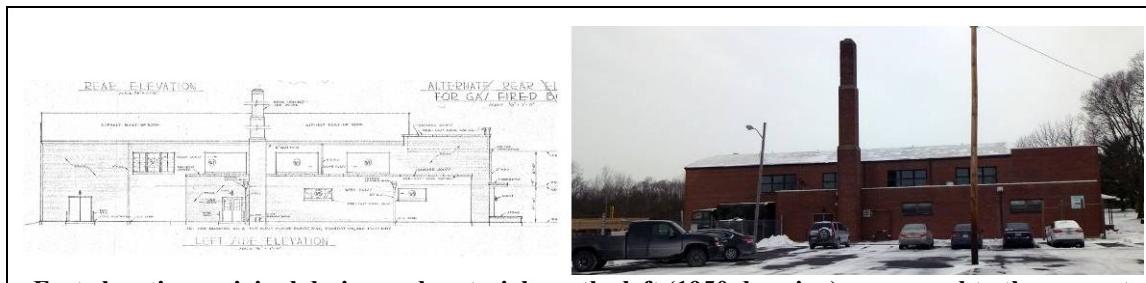
East elevation: original design and materials on the left (1950 drawing), compared to the current condition of the elevation with replacement doors and windows on the right (ERDC-CERL, 2014).

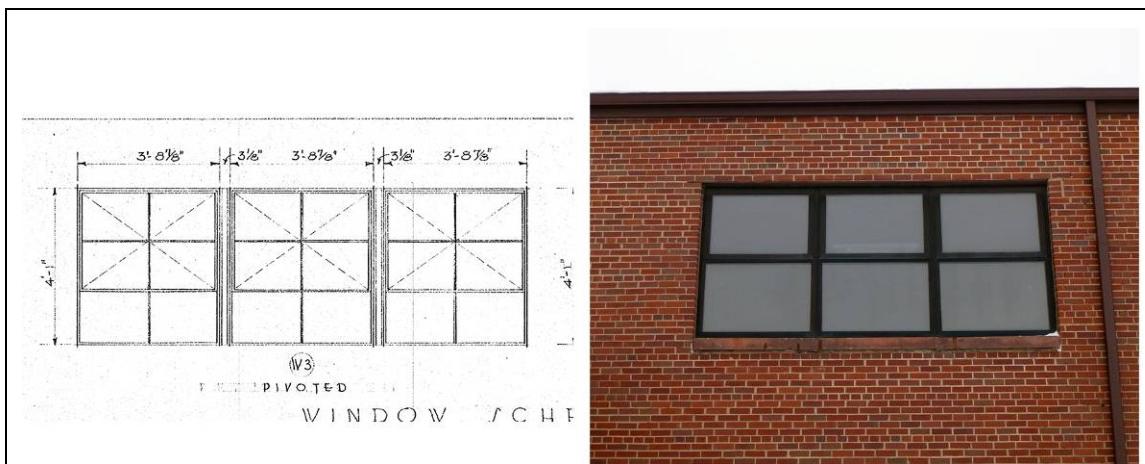
Clerestory windows on the east and west elevations: original design and materials on the left (1950 drawing), compared to the current condition with replacement anodized-bronze aluminum windows on the right (ERDC-CERL, 2014).

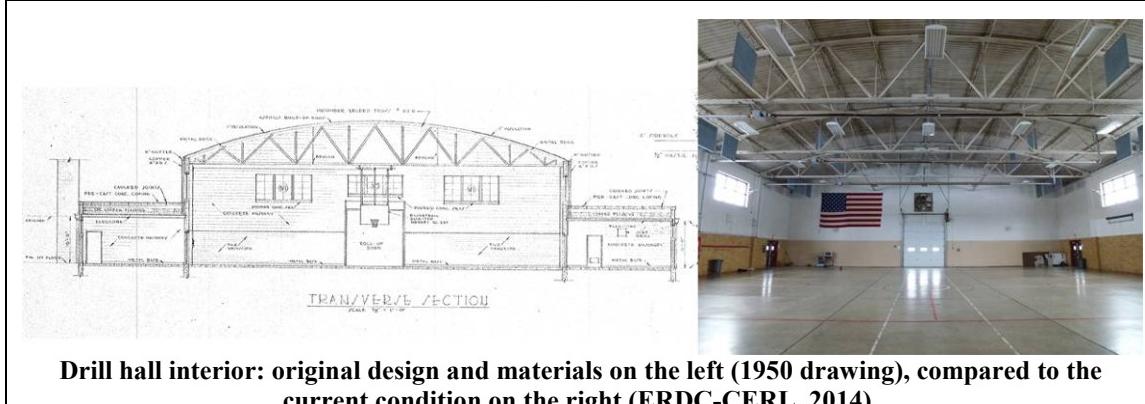
Drill hall interior: original design and materials on the left (1950 drawing), compared to the current condition on the right (ERDC-CERL, 2014).

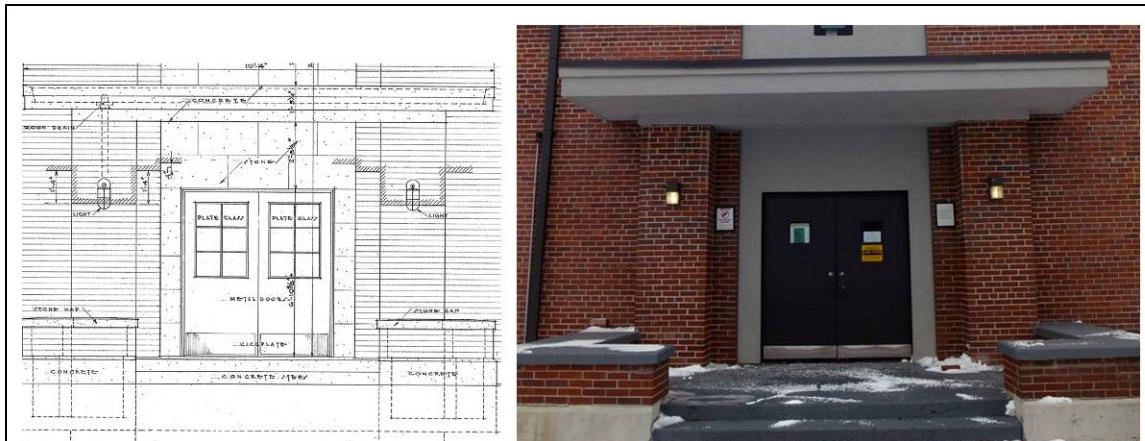
Close-up North main entry on the east (front) elevation: original design and materials: flat canopy, stone-capped bench/half walls, light fixtures, metal and glass windows, and stone tiles framing the entry bay on the left (1950 drawing), compared to the current replacement one-over-one anodized-bronze aluminum window, replacement entry doors, and replacement light fixtures on the right (ERDC-CERL, 2014).

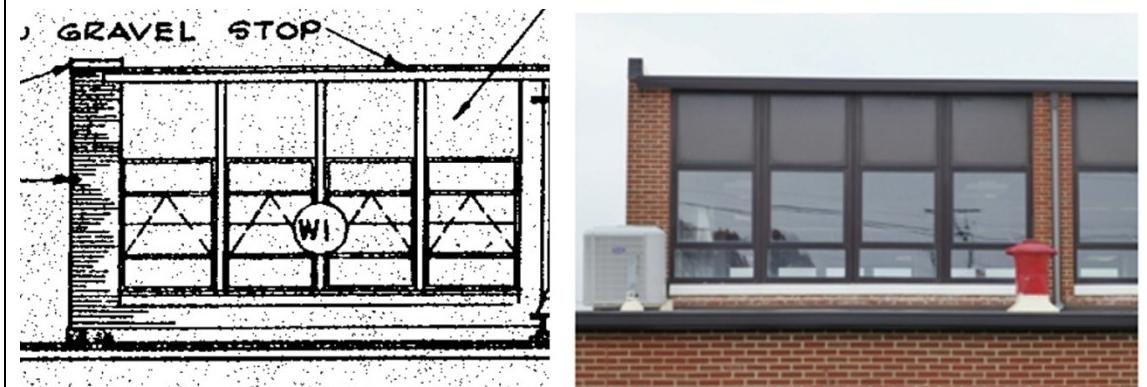
Clerestory windows on the east and west elevations: original design and materials with four-pane awning windows with laminated porcelain enamel panels above on the left (1952 drawing), compared to the current condition, replacement one-over-one anodized-bronze aluminum windows and fiberglass panel inserts above on the right (ERDC-CERL, 2014).

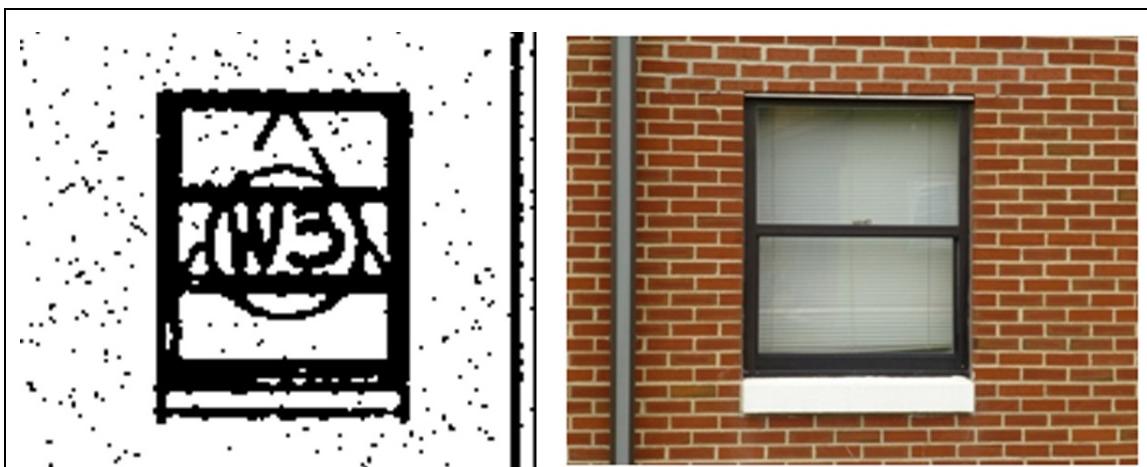
Single windows: original design and materials with three-pane awning windows on the left (1952 drawing), compared to the current condition, replacement one-over-one anodized-bronze aluminum windows on the right (ERDC-CERL, 2014).

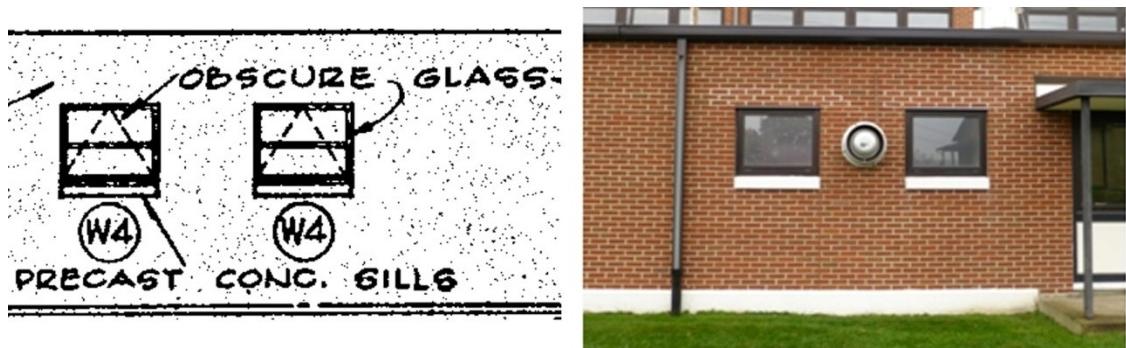
Small single windows: original design and materials with three-pane awning windows on the left (1952 drawing), compared to the current condition, replacement one-over-one anodized-bronze aluminum windows on the right (ERDC-CERL, 2014).

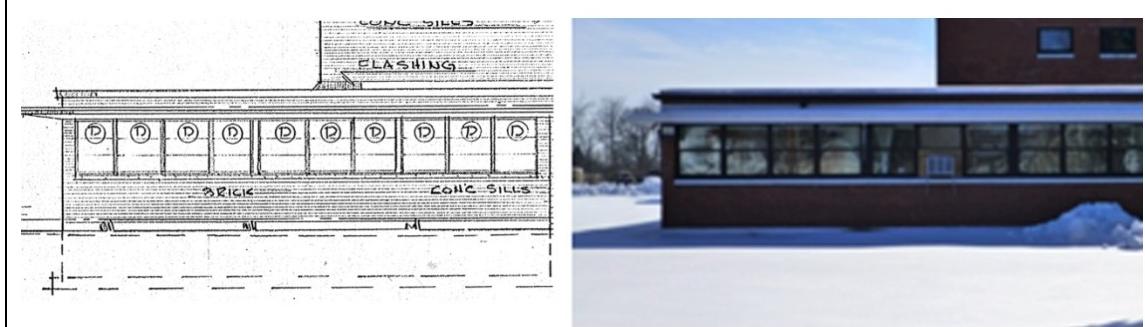
Ribbon-style windows: original design and materials with three-pane steel-sash awning windows with concrete sunshade canopy above on the left (1954 drawing), and the current photograph with replacement anodized-bronze aluminum one-over-one windows on the right (ERDC-CERL, 2014).

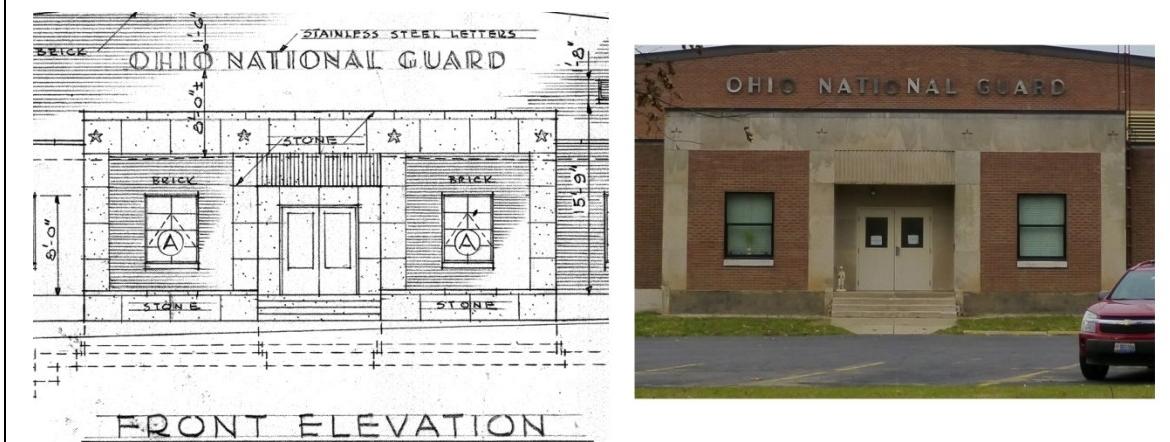
Close-up of main entry on the south (front) elevation: original design and materials with stone tile detailing framing entryway, multipane steel awning windows, metal and glass entry doors, Stainless-steel lettering on the left (1960 drawing), compared to the current condition of the elevation with replacement anodized-bronze aluminum one-over-one windows and replacement doors on the right (ERDC-CERL, 2013).

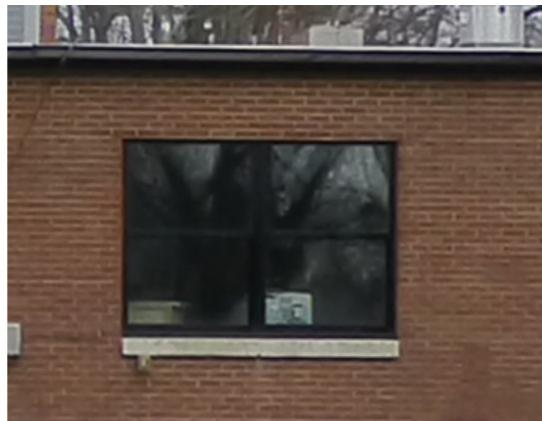
Paired windows on the east and west elevations: original design and materials with multipane steel awning windows on the left (1960 drawing), compared to the current condition of the elevation with replacement anodized-bronze aluminum one-over-one windows on the right (ERDC-CERL, 2013).

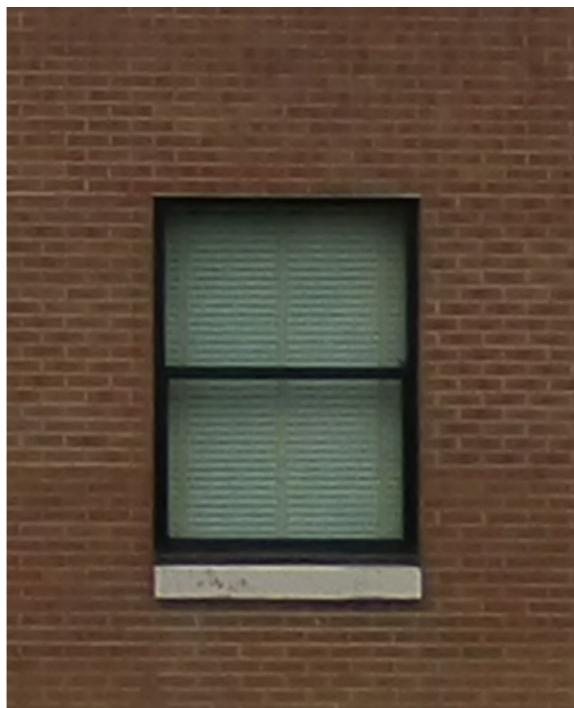
Single window: original design and materials with multipane steel awning window on the left (1960 drawing), compared to the current condition of the elevation with replacement anodized-bronze aluminum one-over-one window on the right (ERDC-CERL, 2013).

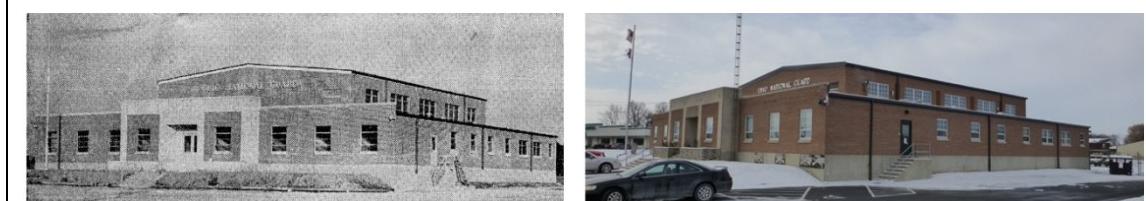
Northeast oblique: original design and materials on the left (1962 photo), compared to the current condition of the front elevation replacement windows and doors on the right (ERDC-CERL, 2014).

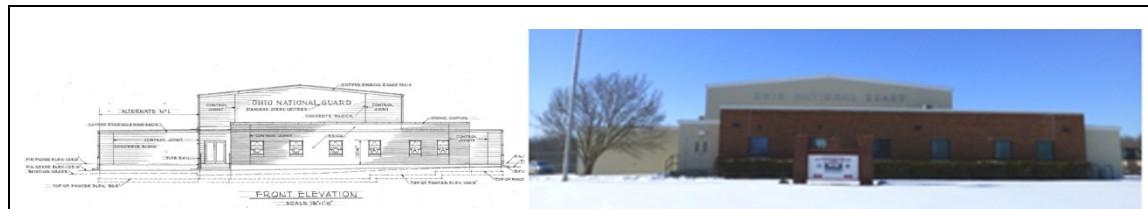
East (front) elevation: original design and materials on the left (drawing), compared to the current condition of the elevation on the right (ERDC-CERL, 2014).

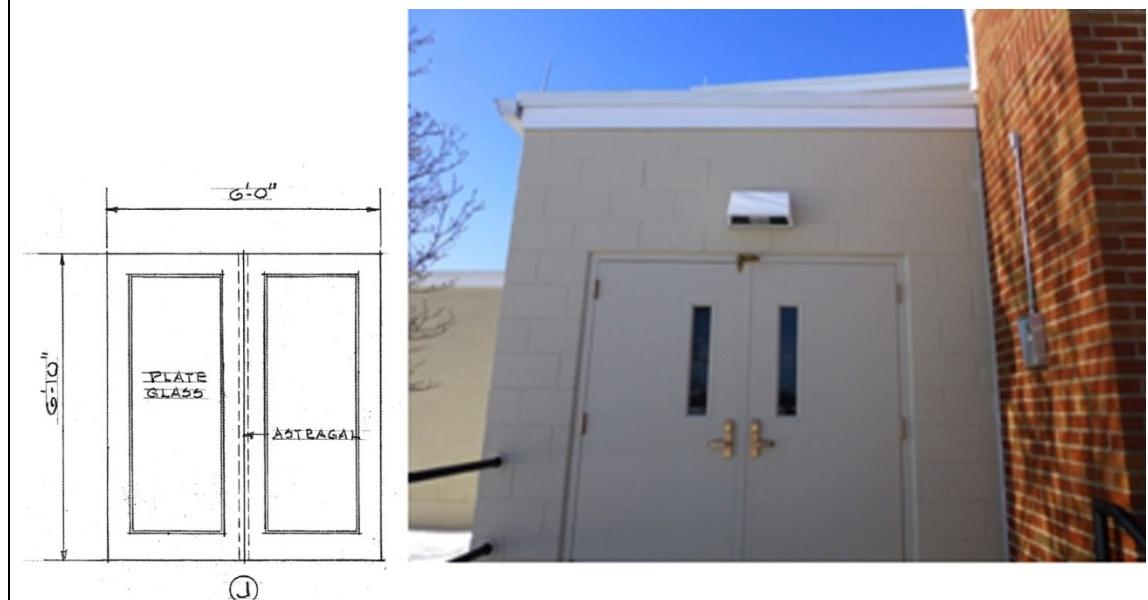
Main entry doors on the east (front) elevation: original design and materials with metal and plate-glass on the left (drawing), compared to the current condition of the replacement metal door on the right (ERDC-CERL, 2014).

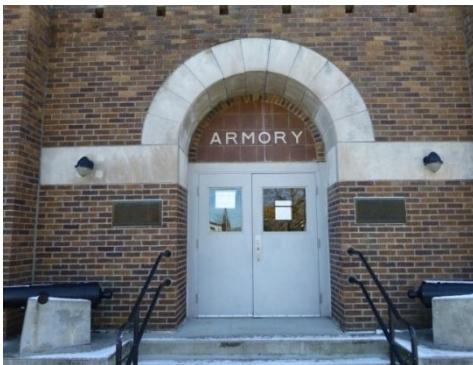
<p>Arched stone detailing framing semi-circle tile artwork of the front entry [metal doors are noncontributing] (St. Marys OHARNG Armory, ERDC-CERL, 2013).</p>

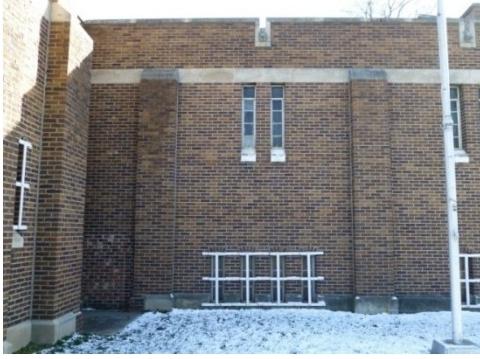
<p>Narrow window openings [metal-sash windows are noncontributing] (St. Marys OHARNG Armory, ERDC-CERL, 2013).</p>

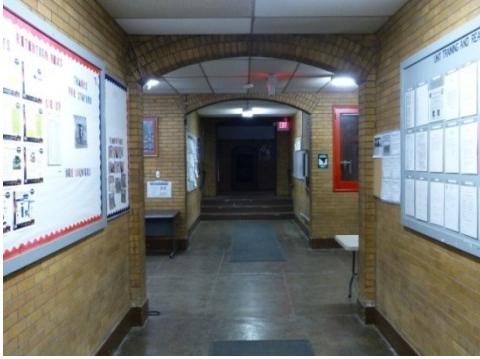
<p>St. Marys OHARNG Armory, interior corridor with brick walls, concrete floor, and arched passageways [drop-ceiling is noncontributing] (ERDC-CERL, 2013).</p>

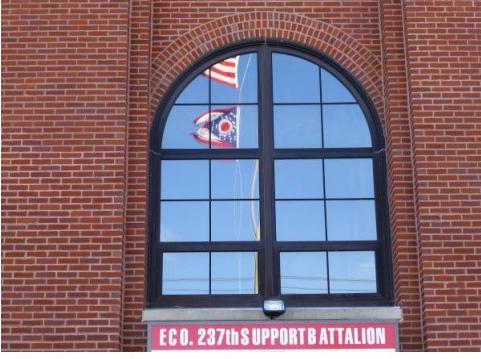
<p>Arched openings on the front elevation [replacement windows are not character defining] (ERDC-CERL, 2013).</p>
--	---

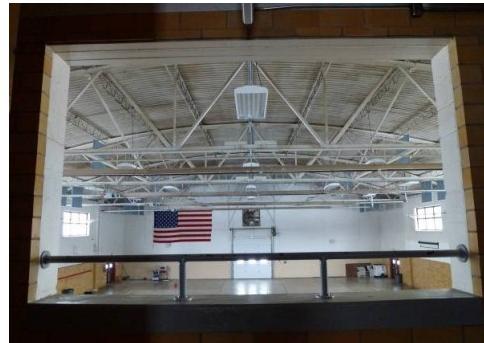
Large window opening from the second floor corridor overlooking the open space of the drill hall (ERDC-CERL, 2014).

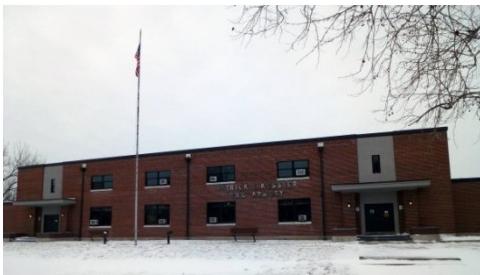
<p>East (front) elevation, symmetrical façade, brick exterior walls, repetitive window pattern, two main entries (ERDC-CERL, 2014).</p>

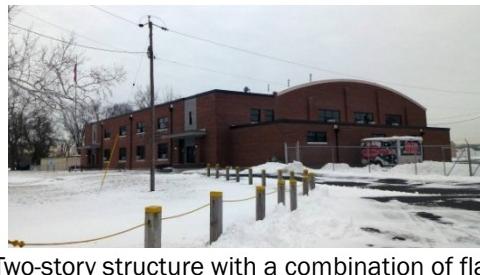
<p>Two-story structure with a combination of flat roof and barrel roof (ERDC-CERL, 2014).</p>

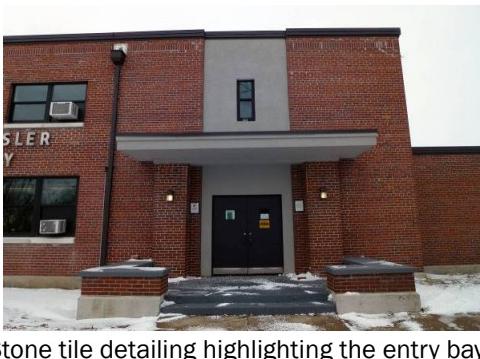
<p>Stone tile detailing highlighting the entry bay, brick/concrete/slate benches, slate porch (ERDC-CERL, 2014).</p>

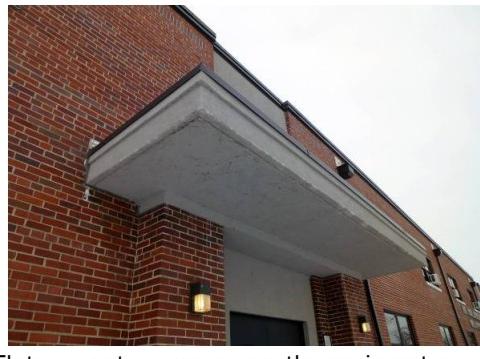
<p>Flat concrete canopy over the main entry (ERDC-CERL, 2014).</p>

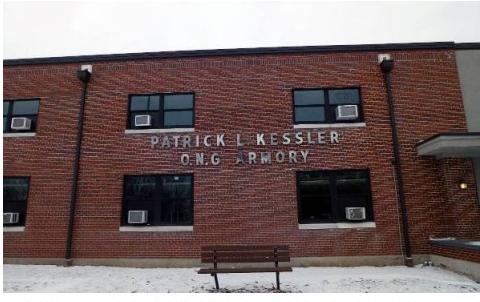
<p>Stainless-steel lettering, paired window placement (ERDC-CERL, 2014).</p>

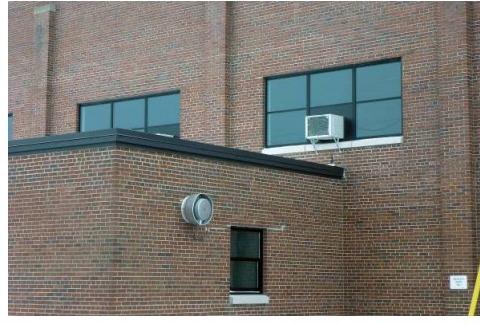
<p>Clerestory windows, not original (ERDC-CERL, 2014).</p>

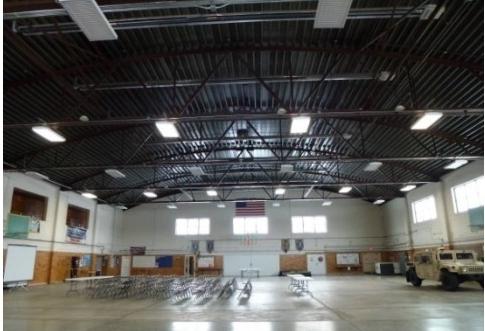
<p>Interior view of the double-height drill hall space with concrete floor, concrete and glazed sanitary tile walls, barrel roof with exposed arched truss system (ERDC-CERL, 2014).</p>

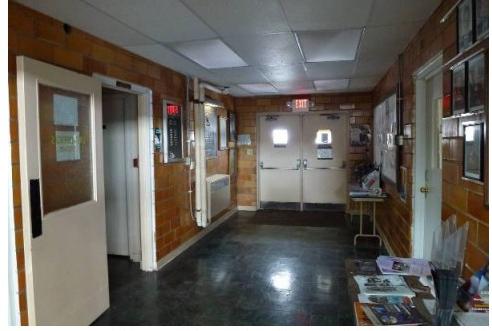
<p>Glazed sanitary tile walls in the lobby (ERDC-CERL, 2014).</p>

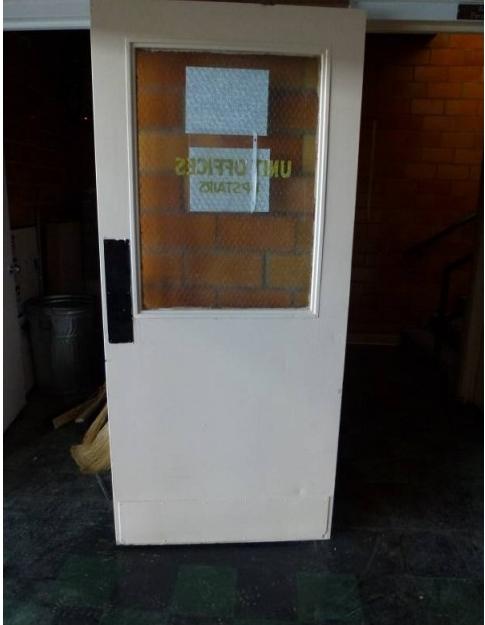
<p>Metal and glass interior door (ERDC-CERL, 2014).</p>

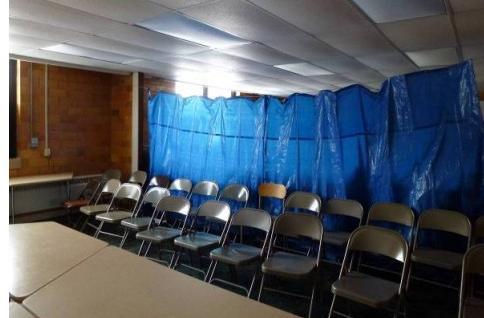
Large classroom space (missing accordion room divider) with glazed sanitary tile walls (ERDC-CERL, 2014).

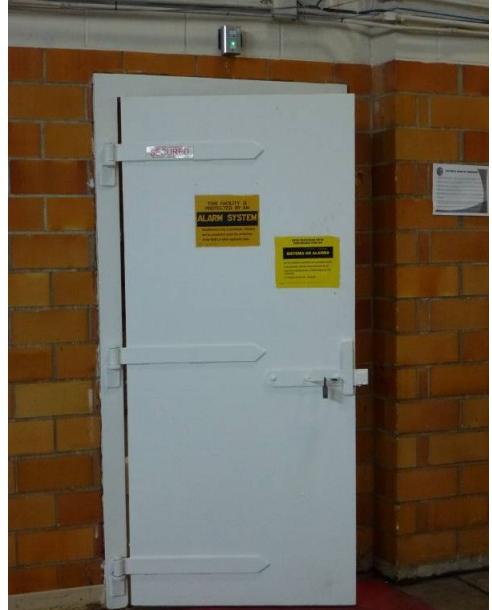
Steel supply room door (ERDC-CERL, 2014).

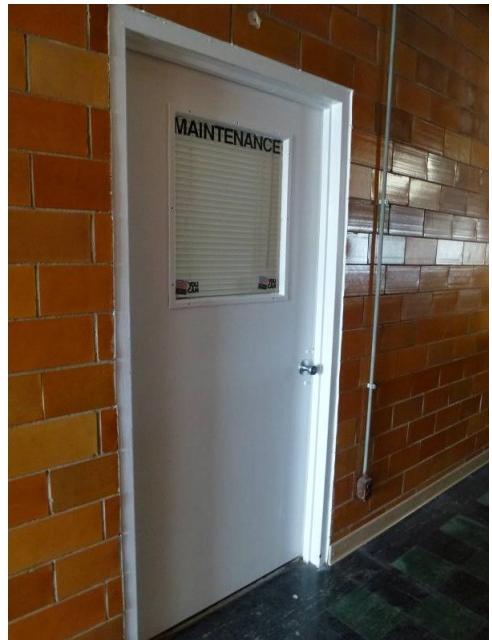
Typical metal and glass office door (ERDC-CERL, 2014).

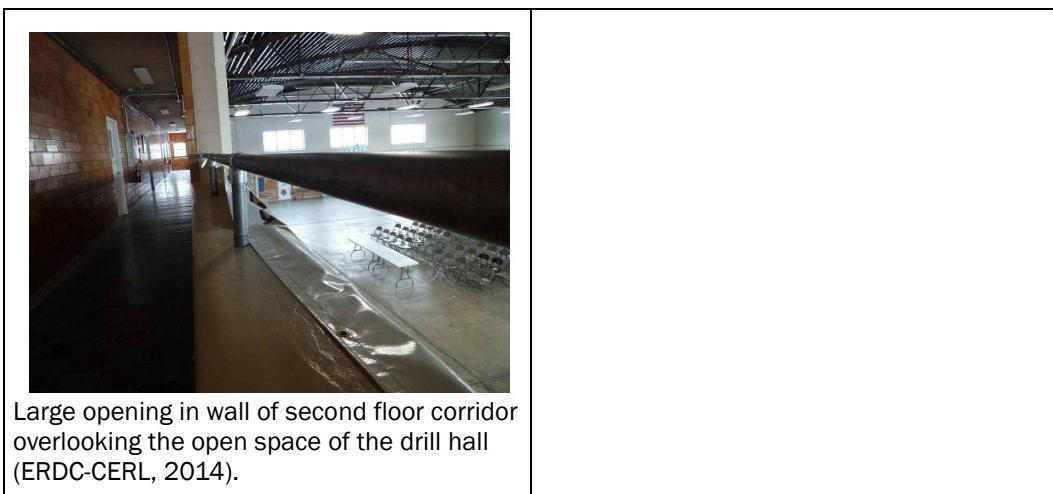
Large opening in wall of second floor corridor overlooking the open space of the drill hall (ERDC-CERL, 2014).

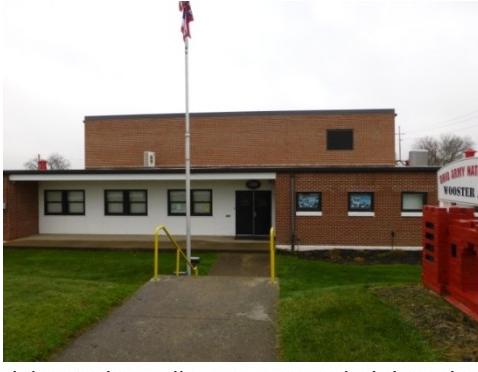
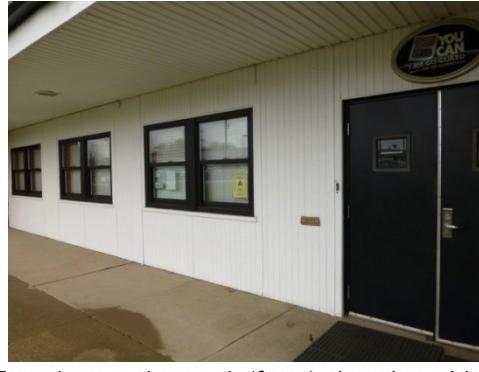
<p>Brick exterior walls, one-story administration wings with central high-bay drill hall space, flat roofs (ERDC-CERL, 2014).</p>	<p>Entry bay on the north (front) elevation with original wood paneled wall, replacement one-over-one anodized-bronze aluminum paired windows, and replacement metal entry doors (ERDC-CERL, 2014).</p>

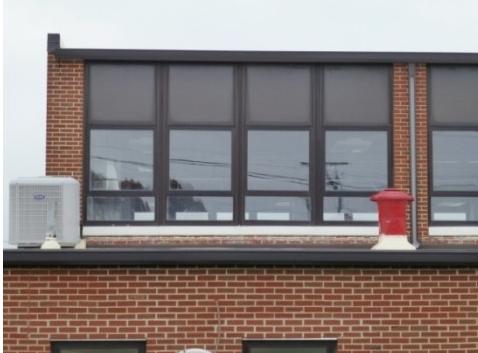
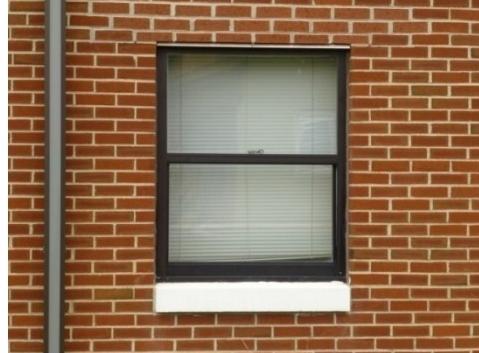
<p>Original clerestory window openings with replacement anodized-bronze aluminum clerestory windows with fiberglass panel inserts (ERDC-CERL, 2014).</p>	<p>Original single window opening with replacement anodized-bronze aluminum one-over-one window on the right side of the west elevation (ERDC-CERL, 2014).</p>

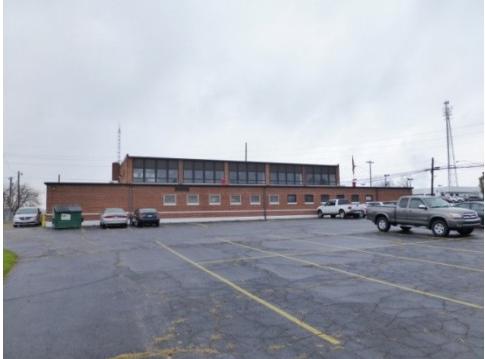
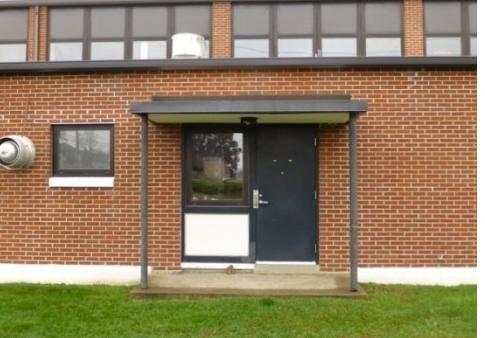
<p>Repetitive window patterns (ERDC-CERL, 2014).</p>	<p>Replacement anodized-bronze aluminum single-pane window with fiberglass panel below, replacement metal entry door, and flat roof canopy the west elevation (ERDC-CERL, 2014).</p>

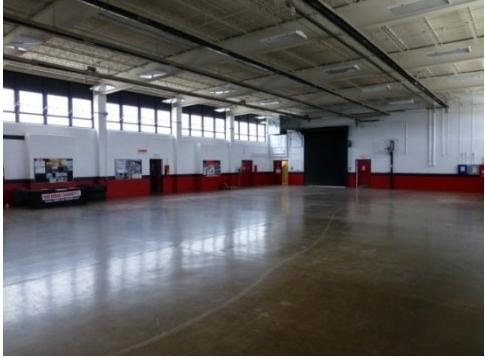
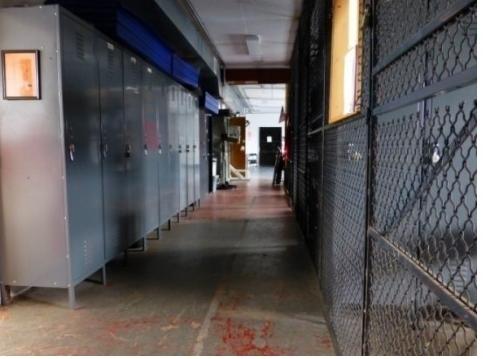
<p>Interior view of the open drill hall, concrete floor, clerestory windows, concrete-block walls, and steel I-beam roofing system (ERDC-CERL, 2014).</p>	<p>Interior view of the modified space of the original rifle range (ERDC-CERL, 2014).</p>

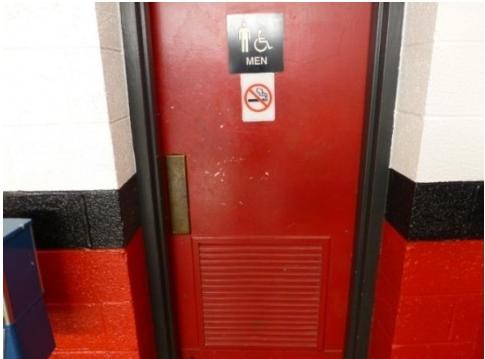
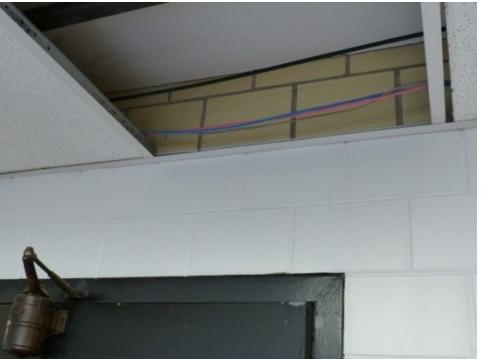
<p>Original door into the men's latrine (ERDC-CERL, 2014).</p>	<p>Looking up at the original unpainted glazed sanitary tile walls of the latrine (ERDC-CERL, 2014).</p>

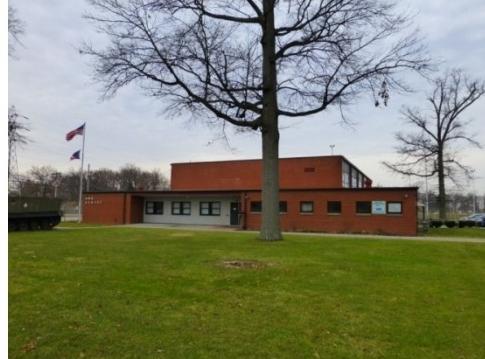
<p>Brick exterior walls, one-story administration wings with central high-bay drill hall space, flat roofs (ERDC-CERL, 2013).</p>

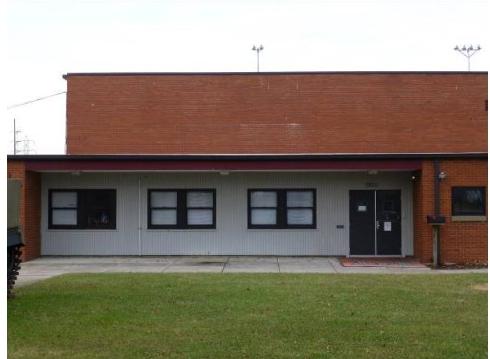
<p>Entry bay on the east (front) elevation with original wood paneled wall, replacement one-over-one anodized-bronze aluminum paired windows, and paired replacement metal entry doors (ERDC-CERL, 2013).</p>

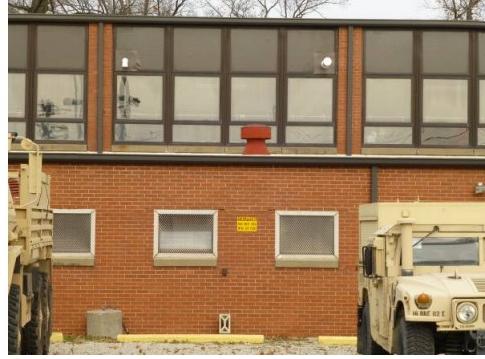
<p>Original clerestory window openings with replacement anodized-bronze aluminum windows with fiberglass panel inserts (ERDC-CERL, 2013).</p>

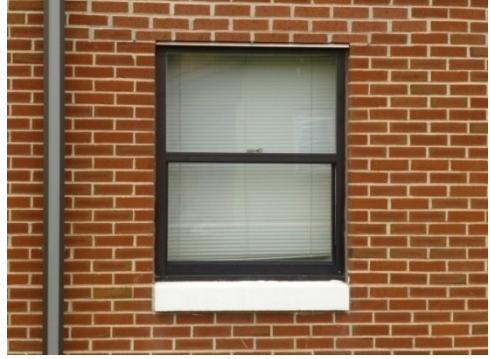
<p>Original single window opening with replacement anodized-bronze aluminum one-over-one window on the right side of the west elevation (ERDC-CERL, 2013).</p>

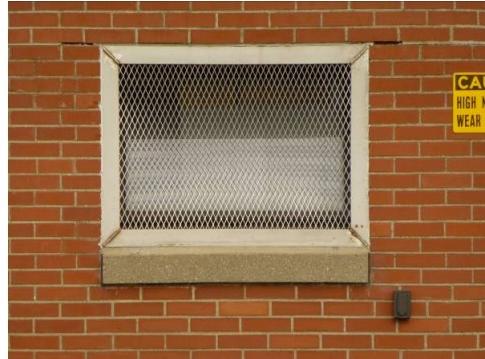
<p>Original small single window opening with replacement anodized-bronze aluminum window with metal mesh screen cover (ERDC-CERL, 2013).</p>

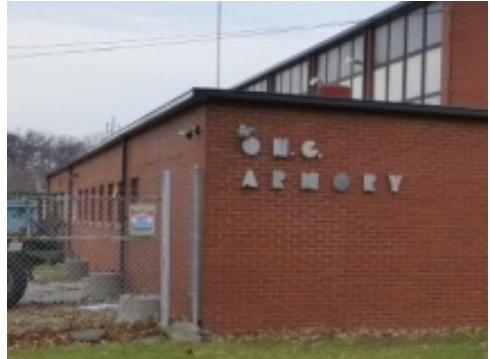
<p>Original Stainless-steel lettering (ERDC-CERL, 2013).</p>

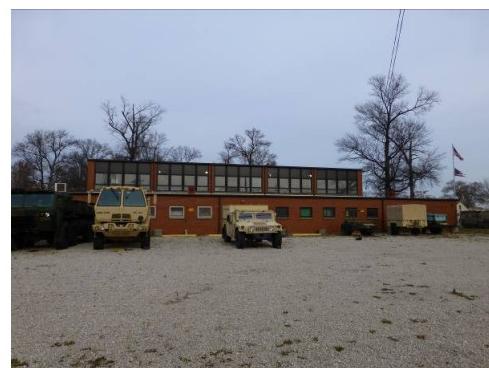
Repetitive window patterns (ERDC-CERL, 2013).

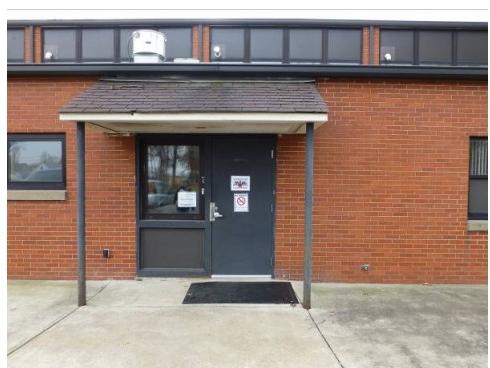
Replacement anodized-bronze aluminum single-pane window with fiberglass panel below, replacement metal entry door, and modified flat roof canopy on the north elevation (ERDC-CERL, 2013).
